Hilliard Road Bridge Improvement Alternatives & Recommendation

Recommendation Summary

Structure Type Study

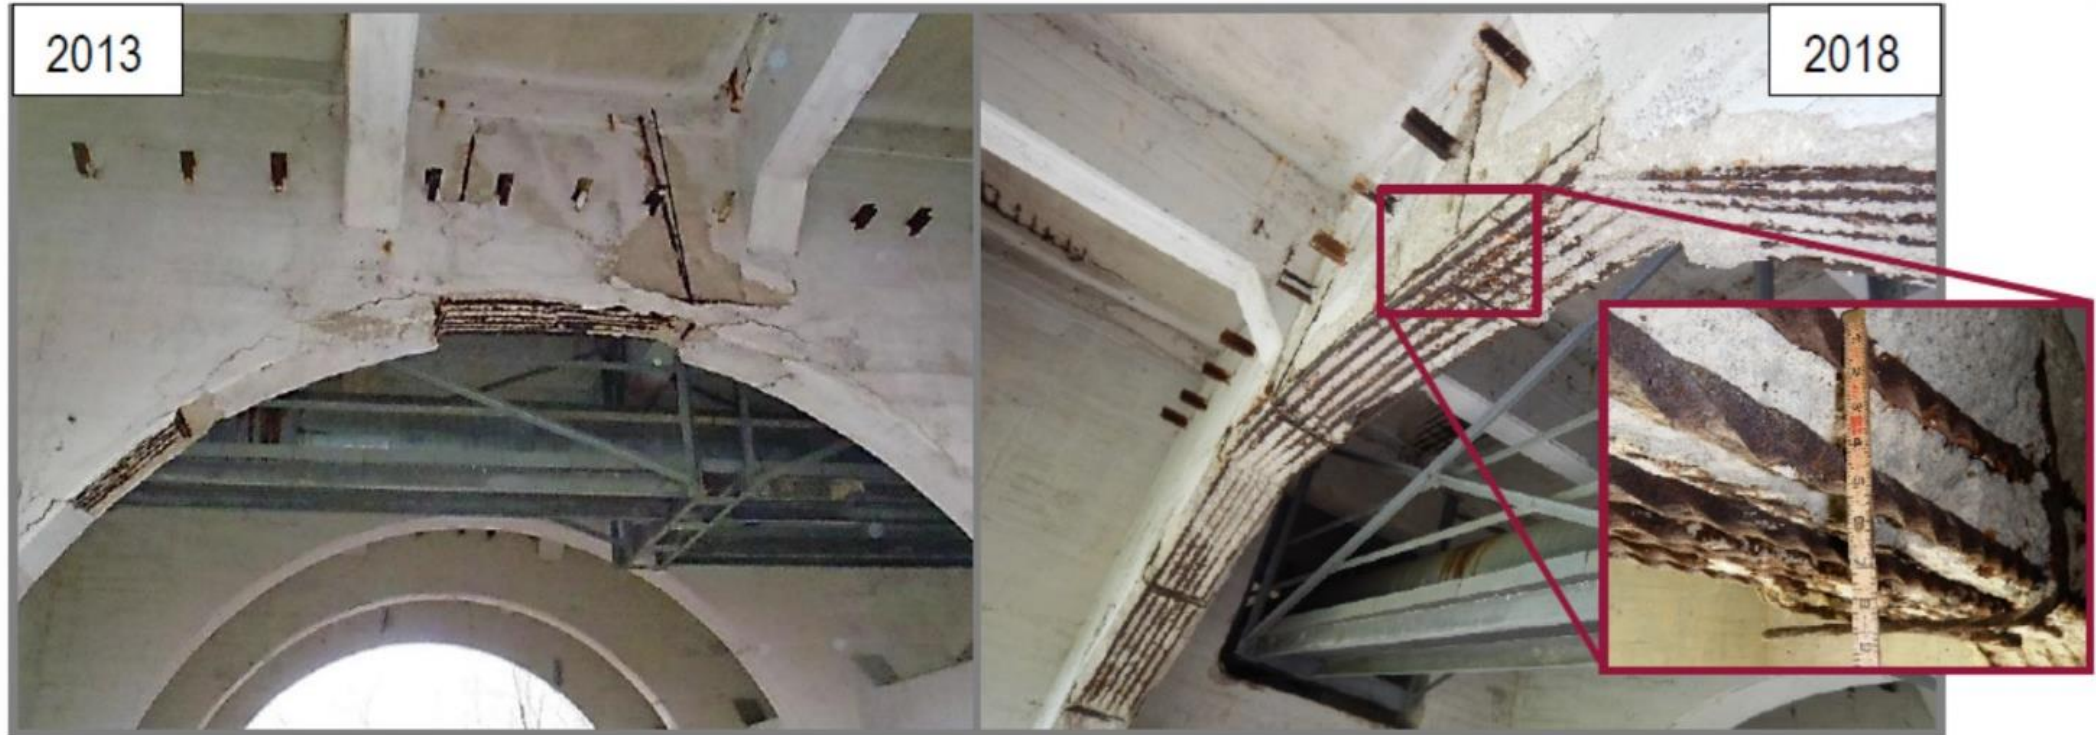
Comparison of 2013 and 2018 Bridge Condition

Deterioration to the underside of the arch

- **2013** – Bridge inspection
- **2015** – Feasibility study prepared, recommended “rehabilitation” of the bridge
- **2018** – Bridge inspection and concrete sampling showed accelerated deterioration of the structure
 - Restrictions on specific trucks and certain heavy emergency vehicles over 29 tons (type I ambulance is 7 tons) traveling on bridge
- **2019** – Revised Feasibility Study

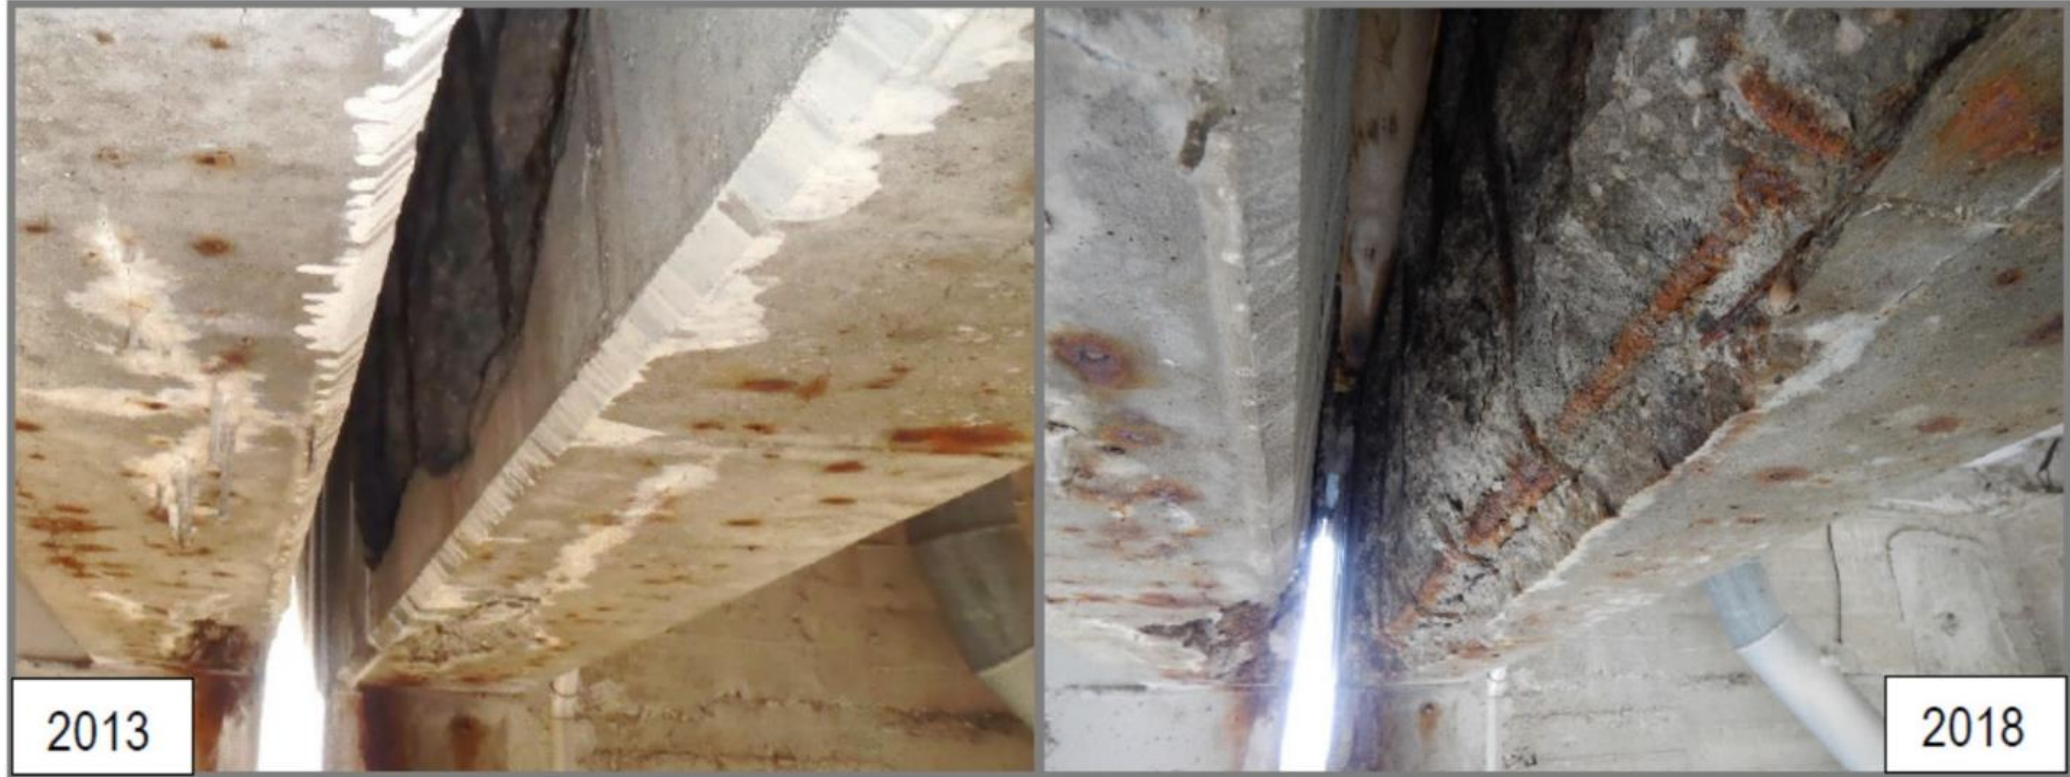
Comparison of 2013 and 2018 Bridge Condition

Concrete deterioration due to seasonal salt usage and freeze-thaw

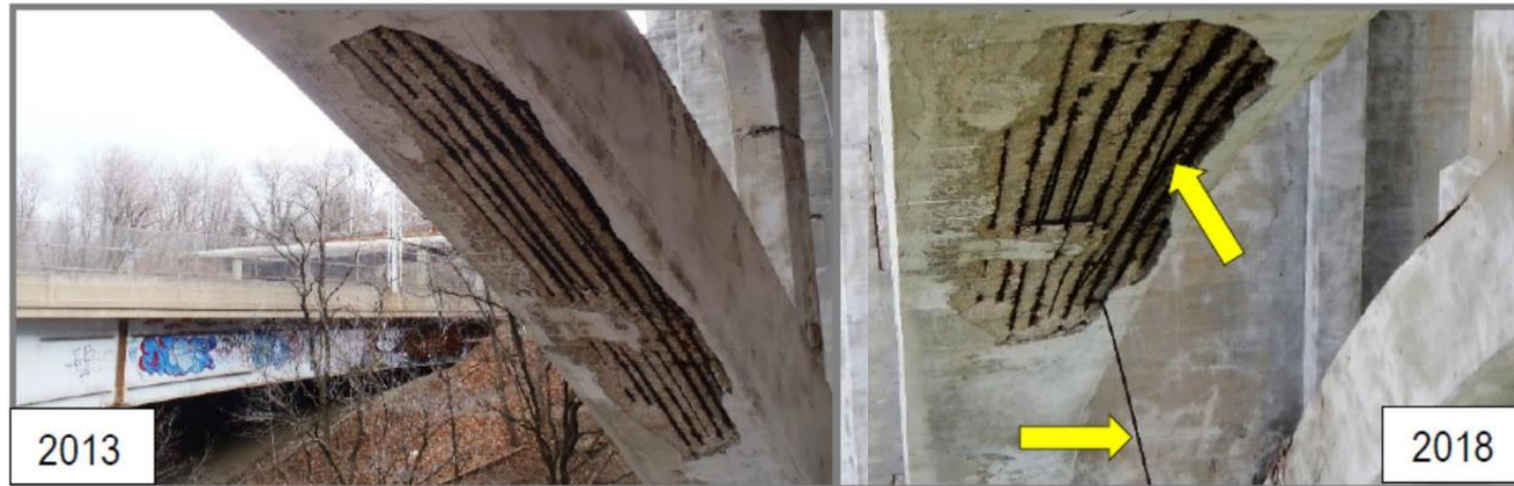
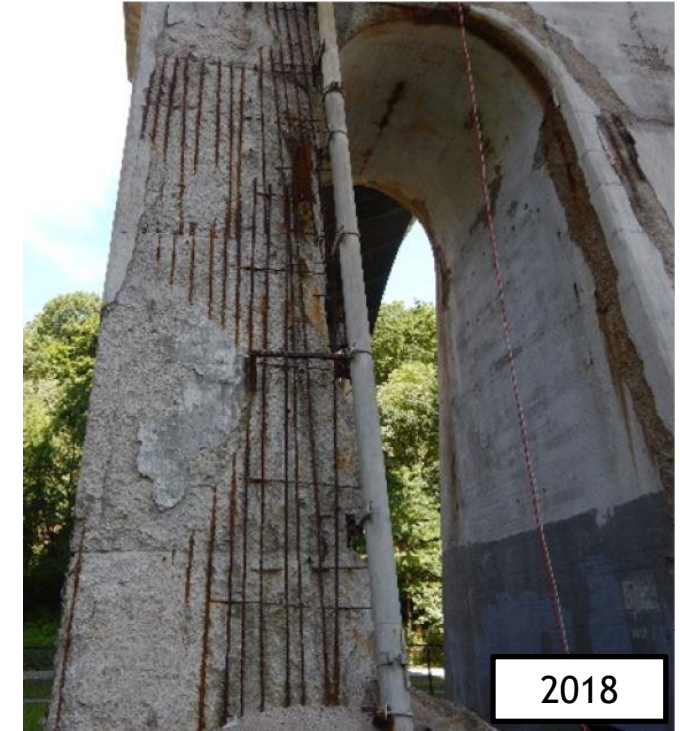
Comparison of 2013 and 2018 Bridge Condition

Increasing deterioration of arches and bridge piers

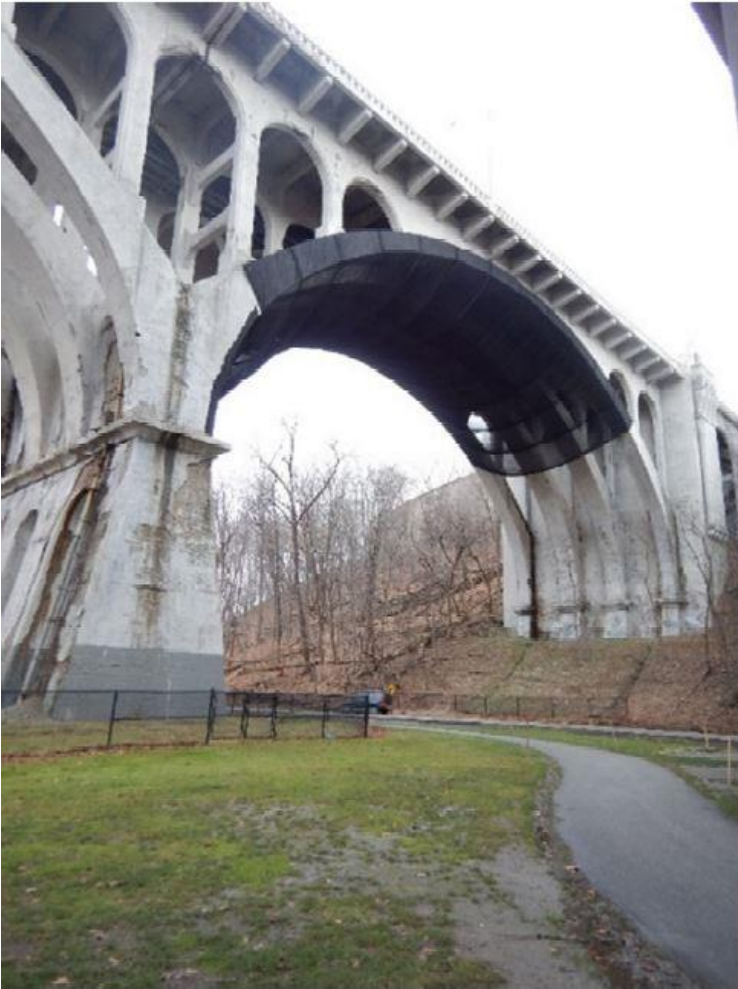
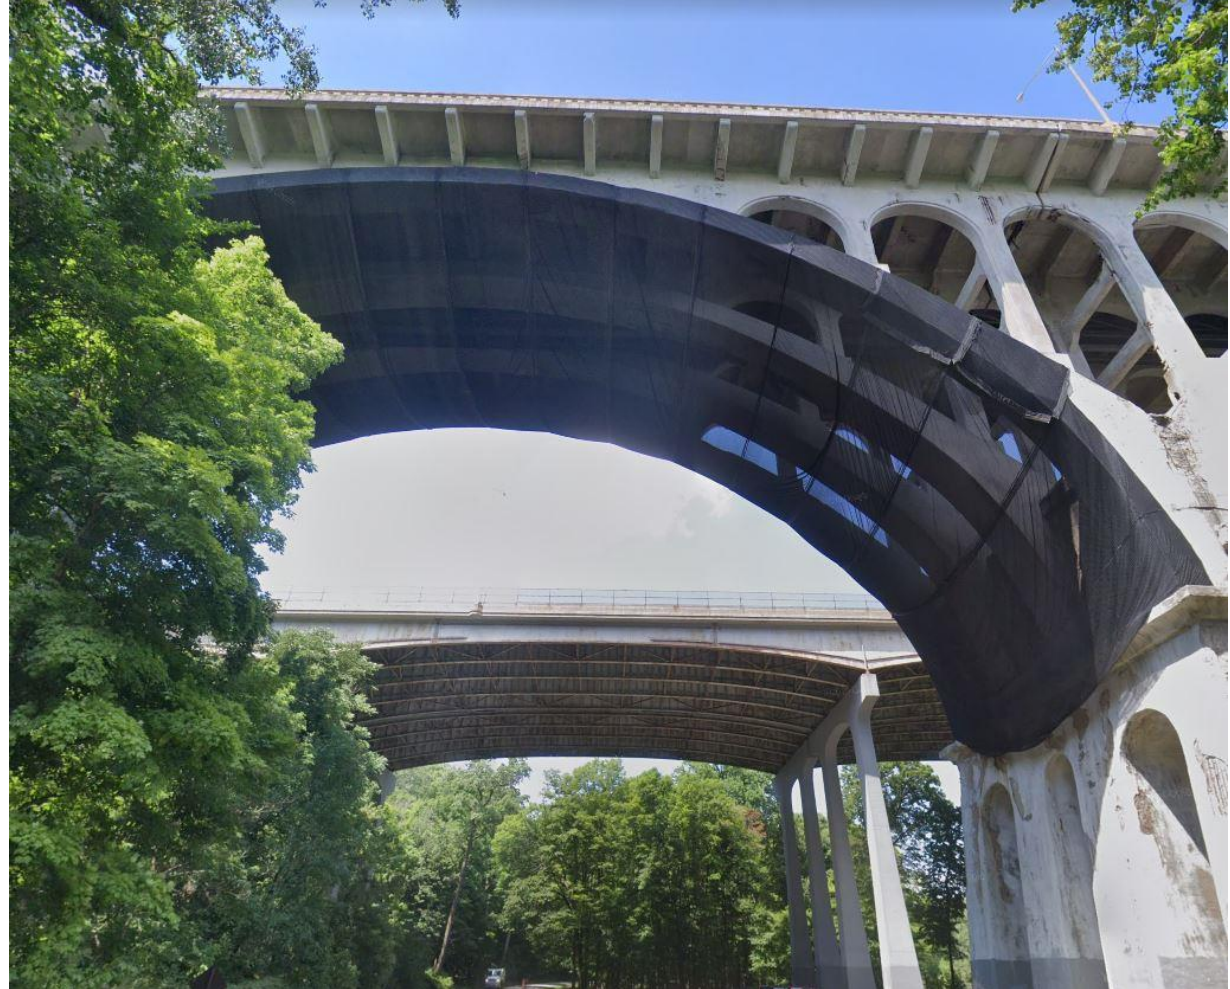
Bridge Netting

Safety netting installed to protect traveling public from falling concrete debris

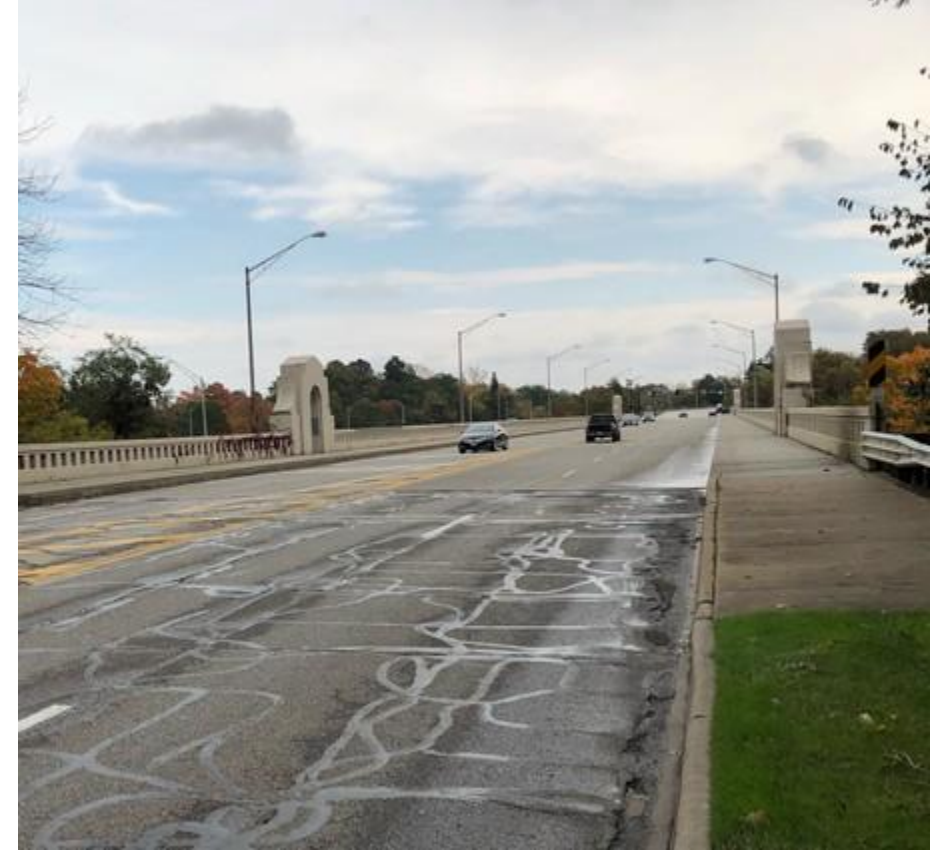
Hilliard Road bridge deck

- Does not fulfill project need
- Would keep current bridge as it is now
- Debris will continue to fall from structure
- Piers in the waterway will remain
- No cost
- Beyond useful life (almost 100 years)
- No construction or maintenance or traffic impacts

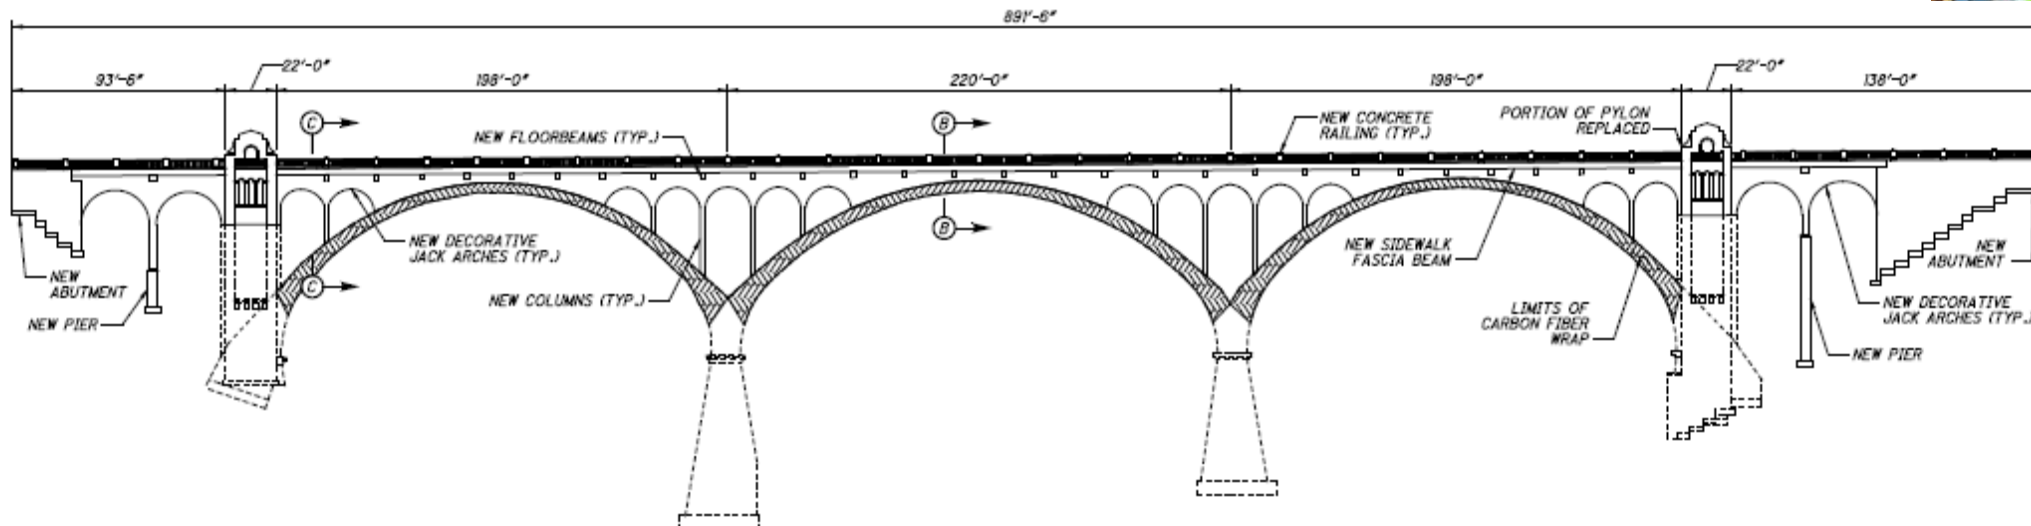
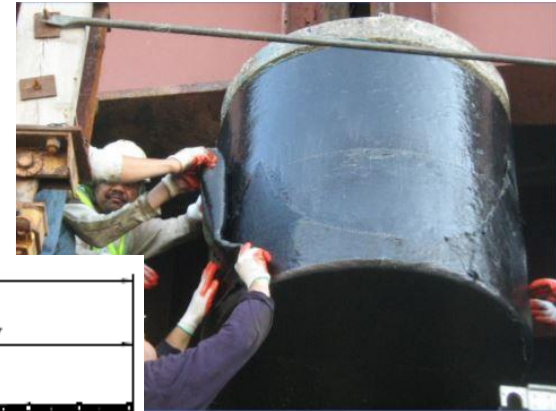
Alternative #2 Rehabilitation

- Partially fulfills project need
- 70% of current bridge will likely be removed
- Temporary park and river impacts during construction, falling debris reduced
- \$52.8 Million (construction and right-of-way cost)
- Estimated design life of 25 years
- Three-year detour during three-year construction
- **Unknown condition/cost**

- Rapid degradation of the structure at an increasing rate (2013-2018)
- Would require more frequent repairs, lifespan of bridge is not greatly increased
- More than 70% of the original bridge will need to be replaced, compromising its historical significance
- Higher risk for unforeseen and unbudgeted construction costs
- Road closures and construction time are not predictable

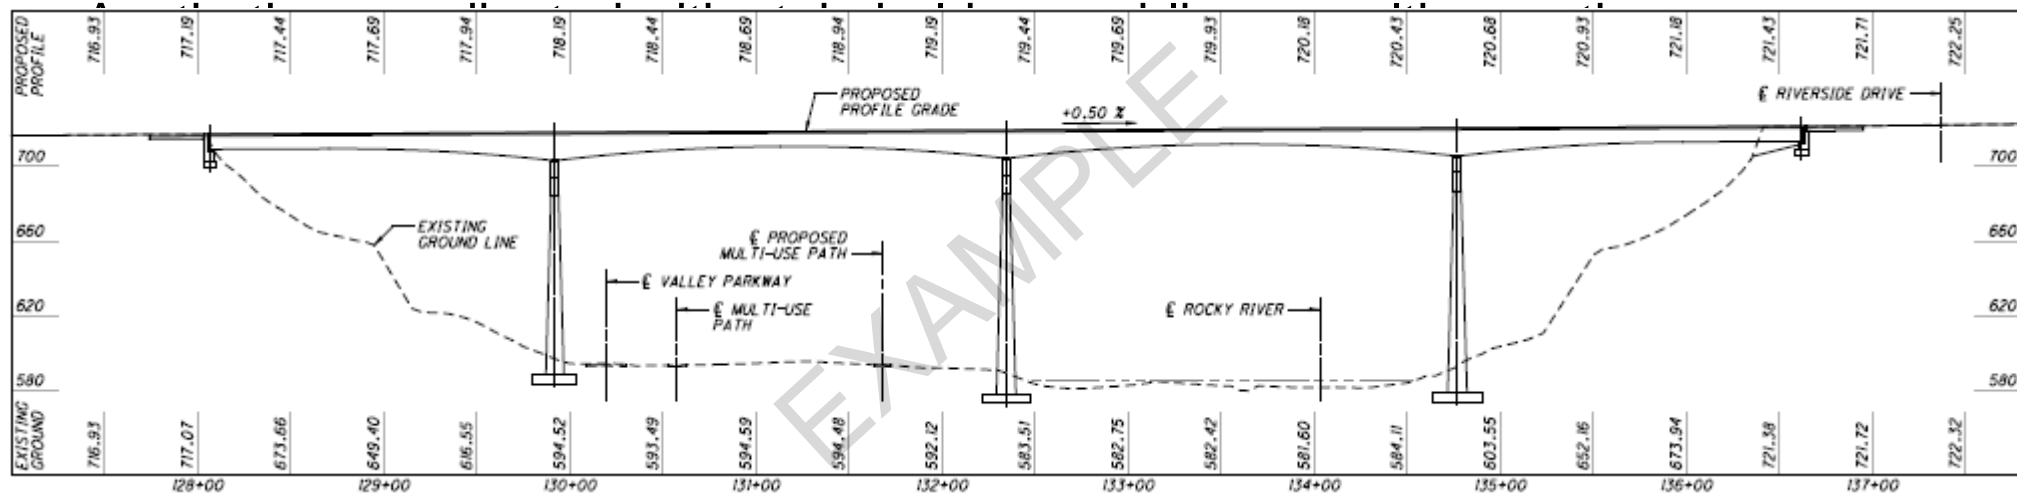
Alternative #3: Removal of the existing bridge and replacement on existing alignment (Recommended Alternative)

- Fulfills project need
- Remove current bridge
- Temporary park and river impacts during construction, no falling debris
- Potential for piers outside of river
- \$40.7-\$55.2 Million depending on the type of bridge (construction and right-of-way cost)
- Estimated 75 years design life
- Two to three-year detour during construction

3	Bridge Replacement	Estimated 75 years.	Meets P&N.	Historic bridge removed.	Can move path back to original location. Potential for improved aesthetics.	Temporary occupation during two-year construction	Two-year temporary causeway. Debris problem alleviated.	Two-year to three-year construction (based on the method of demolition used by the contractor). Detour during construction. Short closure of I-90 during demolition if blasting required.	Temporary from park	\$1.2 Million	<p>Bridge replacement with a <u>4 span</u> high level bridge steel girder structure: \$39.5 million</p> <p>Bridge replacement with concrete prestressed arch bridge: \$54 Million</p>
4	Bridge Replacement - New Alignment, Existing Bridge to Remain	Beyond useful life of remaining structure. Estimated 75 years for new structure.	Does not address P&N; keeps existing structure with continued deterioration and debris.	Historic bridge remains in place. Deterioration continues. Continual maintenance required on existing bridge.	Permanent impacts from new bridge alignment. Debris problem continues.	Temporary impacts during construction. Larger area of vegetation removal.	Two-year temporary causeway. Additional pier in river for new bridge. Debris continues to fall in river.	Two-year construction. Short-term detour to tie in approach pavement after construction of new bridge.	Temp and permanent from park. Relocation of five homes and possibly one condo building.	\$8.2 Million	<p>Bridge replacement with a <u>4 span</u> high level bridge steel girder structure: \$39 million</p> <p>Bridge replacement with concrete prestressed arch bridge: \$54 Million</p>

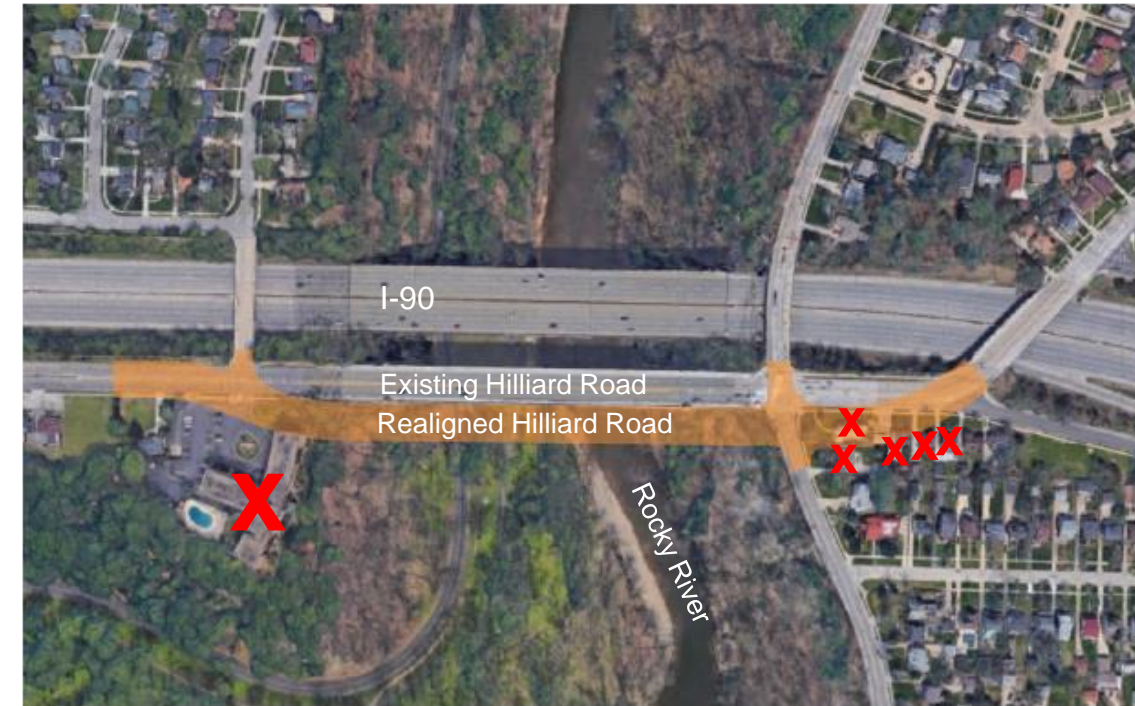
Hilliard Road on New Alignment

- Partially fulfills project need
- Current bridge remains, new bridge built
- Permanent park and trail impacts, permanent relocation of five homes and one condo building (shown as red X's)
- Temporary impacts to park and river during construction
- Debris would continue to fall
- \$47.2-\$62.2 Million depending on the type of bridge (construction and right-of-way cost)
- Does not factor in maintenance costs
- Existing bridge is beyond useful life, new bridge estimated 75 years
- Two-year construction
